Manhole Inspection Summary

Manhole # S11Y__017MH

Insp Date: **5/19/09 8:52 AM**

Location Address: **3309 BENSON AV.**

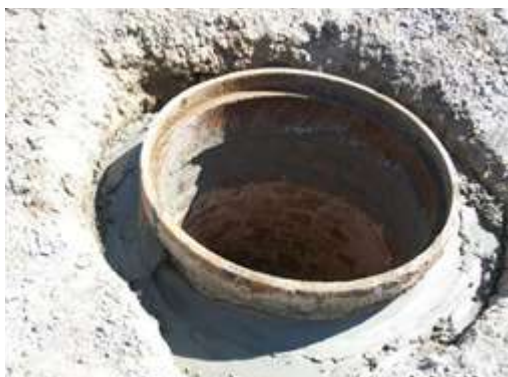
Miscellaneous

MANHOLE WAS RAISED AND
ADJUSTED

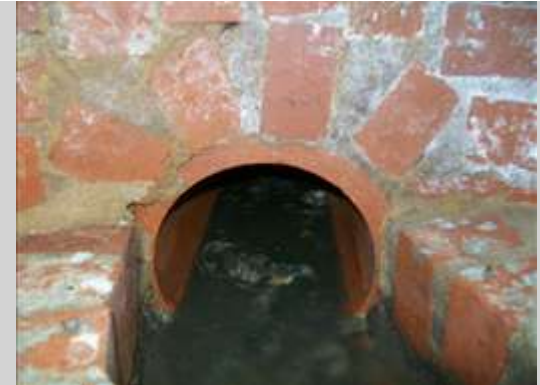
12 O'Clock Outflow

8 in. Circular Gravity Sewer
Pipe Out @ 12 O'Clock

Pipe Height: **8.4** (in.) Rod and Bar (Angled)
Pipe Material: **Clay** ☒ Pipe Lined
Invert Depth: **8.20** (ft.) Flow Characteristics: **None**
Deposits: ☐ None ☐ Mud ☐ Sludge ☒ **Debris** ☐ Grease
Silt Depth: **0** (in.) Deposits Extent: **Light**
Infiltration: **None** Pipe Seal Cond: **Cracked**

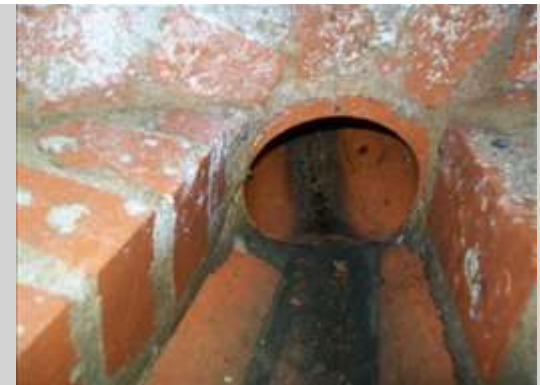
3 O'Clock Inflow

6 in. Circular Gravity Sewer
Pipe In @ 3 O'Clock

Pipe Height: **6** (in.) Rod and Bar (Angled)
Pipe Material: **Clay** ☐ Pipe Lined
Invert Depth: **8.10** (ft.) Flow Characteristics: **Slow**
Deposits: ☒ None ☐ Mud ☐ Sludge ☐ Debris ☐ Grease
Silt Depth: **0** (in.) Deposits Extent:
Infiltration: **None** Pipe Seal Cond: **Sound**

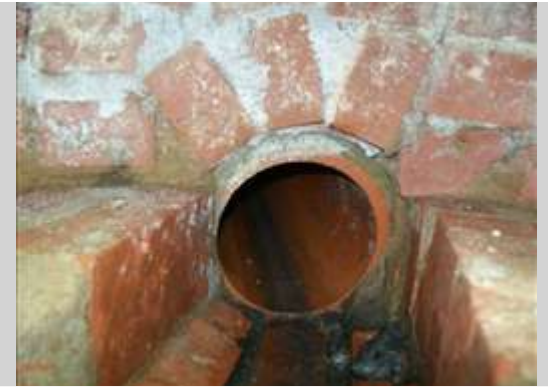
5 O'Clock Inflow

6 in. Circular Gravity Sewer
Pipe In @ 5 O'Clock

Pipe Height: **6** (in.) Rod and Bar (Angled)

Pipe Material: **Clay** ☐ Pipe Lined

Invert Depth: **7.98** (ft.) Flow Characteristics: **Slow**

Deposits: ☒ None ☐ Mud ☐ Sludge ☐ Debris ☐ Grease

Infiltration: **None**

Pipe Seal Cond: **Sound**
